The Track Record of Environmental Impacts Resulting from Pipeline Spills, Accidental Releases and Failure to Capture and Treat Mine Impacted Water

U.S. Gold Mines Spills & Failures Report

JULY 2017

BY BONNIE GESTRING AND JOHN HADDER

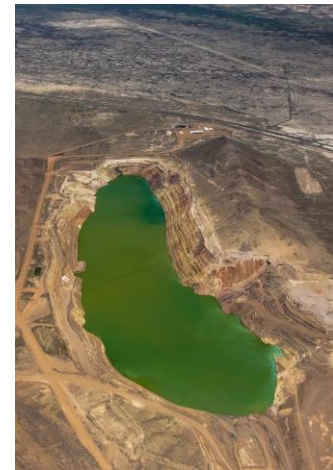
Lone Tree Mine pit lake.

When mining occurs below the water table, dewatering is required to keep the mine dry. Once mining operations cease, ground water seeps back into the underground mine workings, or back into the pit to create a pit lake. For open pit mines, since most gold mines occur in areas of high evaporation, the flow of water is typically into the open pit. However, if outflow occurs, groundwater can be degraded since pit lake water and water from underground mine workings is typically of poorer quality than the surrounding groundwater.
